Comstock Middle School SRTS Walk Audit

Tuesday, August 27th, 2024

Appendix: Walk Audit Pictures:

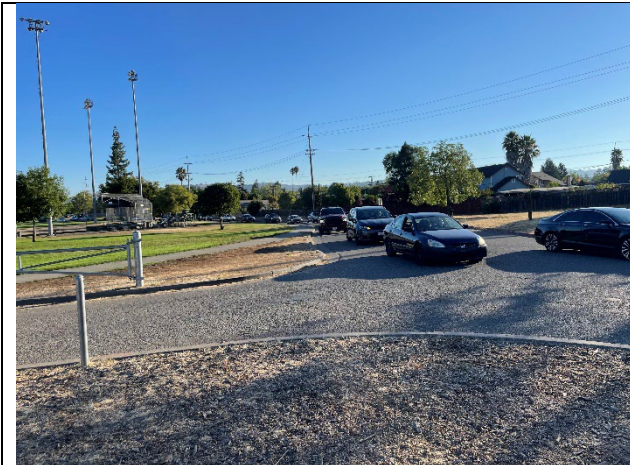
Morning traffic traveling down school driveway; entrance to staff driveway on left of picture

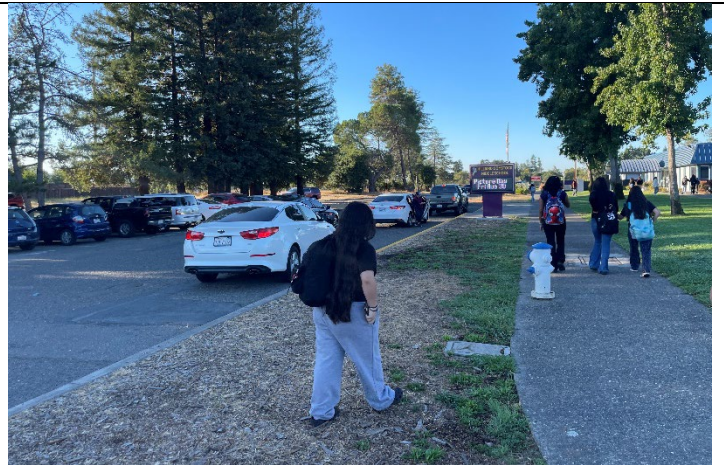
Traffic cue in and sidewalk in front of school, staff only parking on left could have a few spaces converted to visitor

- Convert some of the staff-only parking spaces in front of the school to “visitor parking” to enable parents who were parking in staff parking lot north of campus to park closer to the entrance.

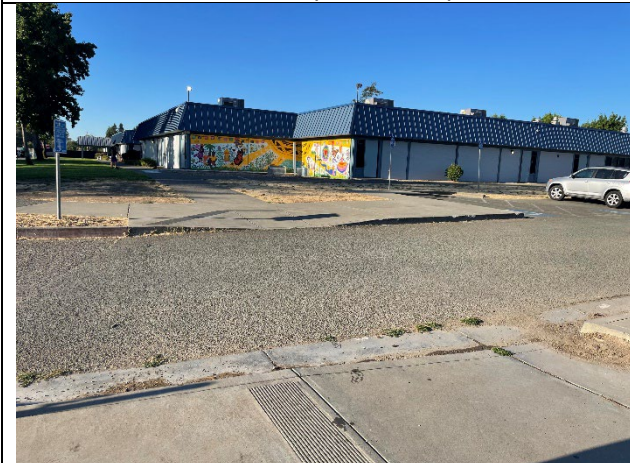
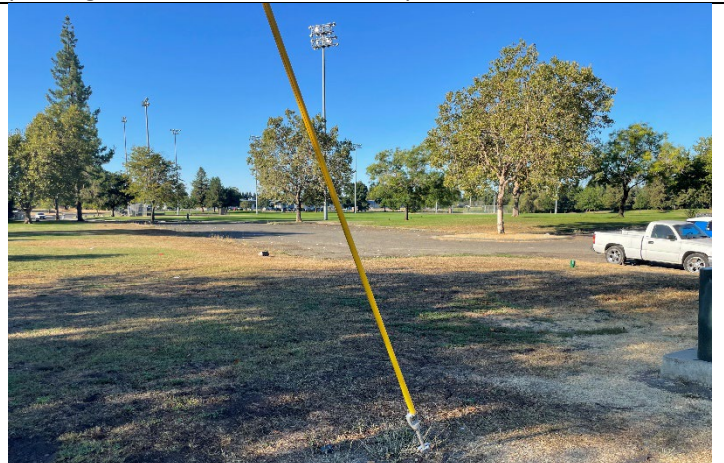
- The curb-ramps are not ADA compliant, nor is there a painted crosswalk, across the driveway into the staff parking lot (mentioned above).
- There is no signage indicating that the staff parking lot is just for staff and that student drop-off is not permitted in that parking lot. In general, signage is lacking in the drop-off zone, and curb paint is faded.

Crossing across entrance to staff driveway; recommend to install crosswalk & ADA accessible curb ramps

- Short term:
 - re-pave and repaint the school driveway
 - repair/repaint speed humps
 - Add ADA-compliant curb ramps with truncated domes, and paint a crosswalk across the driveway to the staff parking lot on the north side of campus.

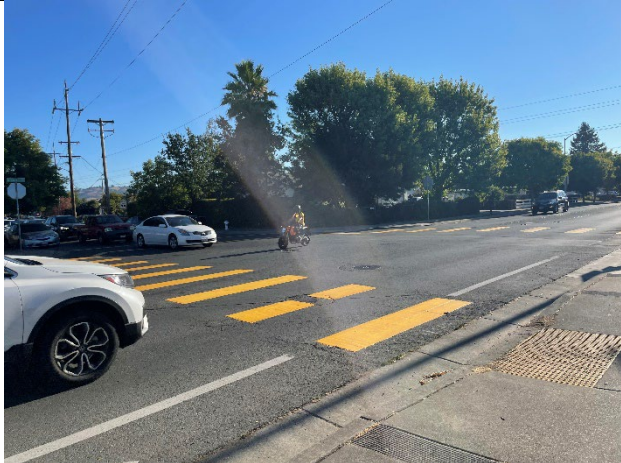
- Students who are dropped off at the bus stop on the north side of W. Steele Lane, ½ a block west of Apache Street, or students walking/bicycling from Apache St. or from the neighborhoods to the east, primarily, as mentioned above, cross at the Apache St. crosswalk (west leg). Students then walk/bicycle to school across the northern parking lot and/or grassy

area west of the neighborhood fence, crossing the school driveway at various locations, before heading down the sidewalk to school. The student in attendance said that this parking lot often has a lot of broken glass in it, so when he bikes, he prefers to bike on the sidewalk along W. Steele Lane and come up on the sidewalk next to the school driveway. Some students do cross at the signalized crossing at the Comstock school driveway, but the majority appear to cross at Apache & W. Steele because it appears to be the “shortest path of travel” to/from school and the bus stop/neighborhood.

Looking across field toward school from crossing at Apache Lane & West Steele Lane – students walk across this grassy area/parking lot and across the school driveway for the “shortest path” to school.

- Construct a paved pathway and designated crossing, from the crossing at W. Steele Lane & Apache way, along the grassy area west of the wooden fence, across school driveway (safest location TBD), to the sidewalk on the west side of the school driveway.

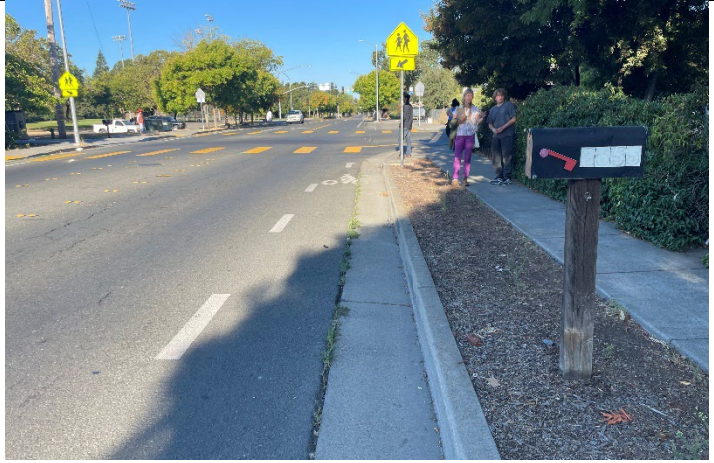
- The Crossing Guard(s) stationed at the crosswalks at W. Steele Lane and Apache Street expressed that drivers often do not obey pedestrian right of way. They expressed that this location is one of the more difficult crosswalks in the area to safely monitor. We observed students primarily crossing West Steele on the western leg of that crosswalk. The Crossing Guard confirmed that this is the primary crossing that students utilize (although she supports crossing at all three legs).

Crossing at Apache St. & West Steele Lane – recommend RRFB for West leg of this crossing

- Improve the safety of the crossing at West Steele Lane & Apache Lane by installing an RRFB at the western leg of that crosswalk, where the majority of students are known to cross. Although the eastern leg of that crosswalk has a shorter crossing distance, the western leg is the logical leg to improve because of predominant usage. Consider bulb-outs to shorten crossing distance as well.

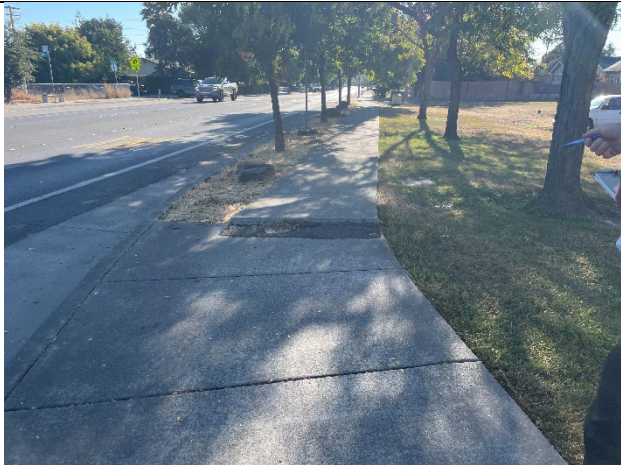
- The student in attendance expressed that when he rides his bicycle to school from Range Avenue to W. Steele Lane, that he mostly travels on the sidewalk, because it feels safer than bicycling along W. Steele Lane, due to the speed of traffic and the fact that the bicycle lanes are relatively narrow with no buffer between traffic and the bicycle lane. The student indicated that he once observed a driver crashing into a bicyclist who was riding down W. Steele Lane in the other direction.

View of West Steele Lane facing west, at Apache St. crossing. Consider feasibility of improvements to bike lane (green?) or sidewalk reconfiguration to put bike lane in-between the sidewalk & refuge area.

- Green bicycle lanes
 - Bulb-outs to shorten crossing distance at crosswalks and make pedestrians more visible to drivers.
 - Reconfiguring the sidewalk to create a buffer between the bicycle lane and West Steele Lane.

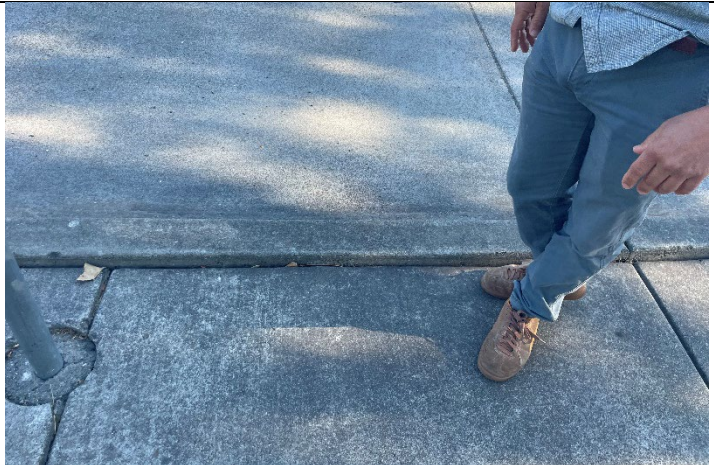
Sidewalk east of bus stop on north side of West Steele, recommend patch repair

- Repair asphalt on sidewalk at the following locations:
 - Crosswalk at Comstock driveway
 - Patch asphalt to the east of the bus stop on the south side of West Steele Lane

- Bus stop # 80281 – eastbound – average daily boardings, alighting's – 25/15
 - Bench is currently at bus stop.
 - **Asphalt patch needed on sidewalk to prevent tripping hazard.**

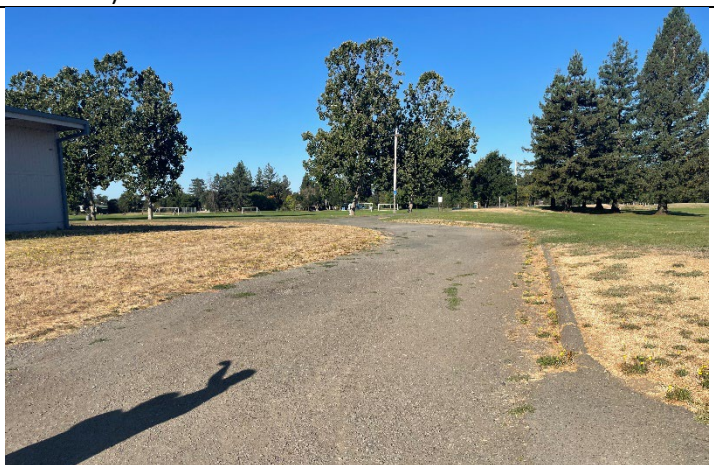
Multi-use pathway in park west of school/baseball fields	Another view of multi-use pathway that continues west of school to Marlow Road (repairs where pathway has deteriorated farther west are needed)

- Repair large cracks in pavement on the multi-use pathway west of the school near the play structures and pump track
